ALAMOS GOLD INC.
YOUNG-DAVIDSON

December 6, 2017

Re: Seepage Overflow at TIA-7 – Initial report

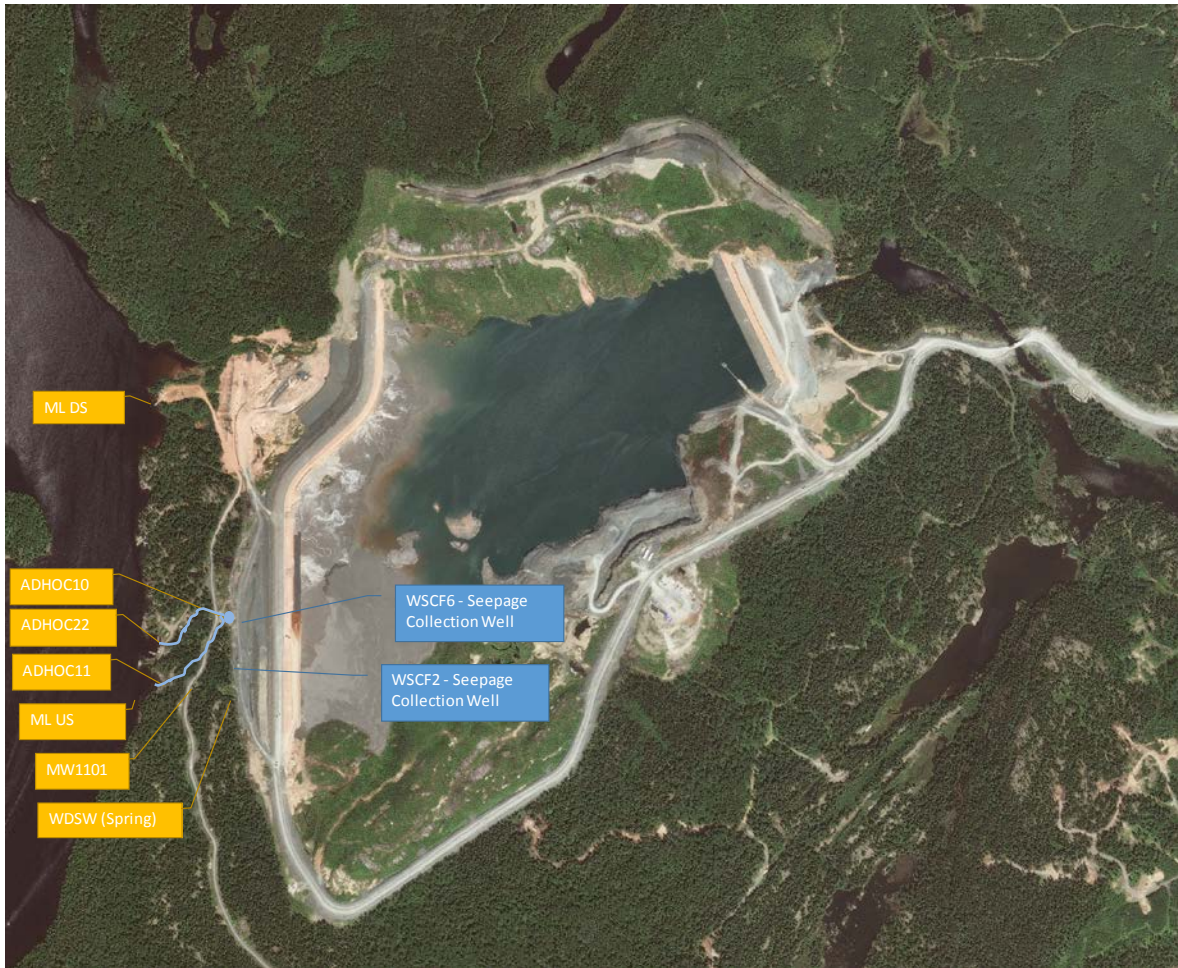
Figure 1

At 8:45 am on December 1, 2017 during the dayshift inspection of the Tailings Impoundment Area, it was observed that seepage was visible downstream of seepage well #6, located at the toe of the west dam of tailings facility TIA7 (see Figure 1). It was observed that the seepage was flowing down gradient towards Mistinikon Lake. The total volume of seepage that flowed into the environment, prior to containment, is estimated at 75 m³.

Initial actions included placing a temporary containment berm of clean sand material to stop the flow of seepage. Portable pumps were utilized to redirect the seepage water from the containment pond back to seepage well #2. Environmental water samples from various locations were collected and sent to the lab for analyses. By 11:30 am flows from the seepage containment area were no longer migrating into the downstream environment.
